## **PROPOSALS FOR REDUCING EMERGENCY STOPPAGES OF HYDROGENERATORS AT UKRAINE HYDRO POWER PLANTS**

**Porada A.V., Shevchenko V.V.**

*National Technical University «Kharkiv Polytechnic Institute», Kharkiv*

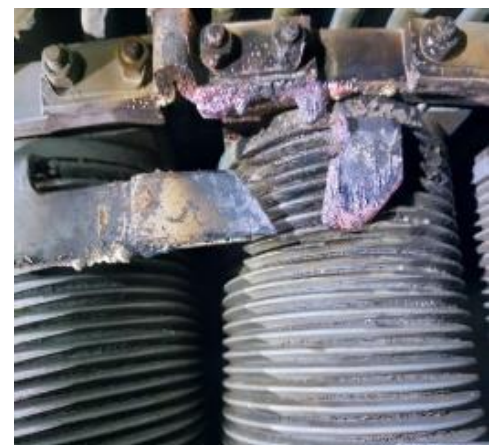
3) cliff of the jumpers of the rotor damper winding due to their incorrect installation, fig. 1;

Fig. 1. Cliff of the jumpers  
of the rotor damper winding

Therefore, the analysis of failures of hydro generators allows us to conclude about the possibility of prolonging their operation, despite significant wear and tear. Because in modern conditions it is impossible to replace with new equipment, and the main reasons for the failure of hydro generators are insufficient quality maintenance and repairs, which can be corrected.
